Stay Grounded in PM

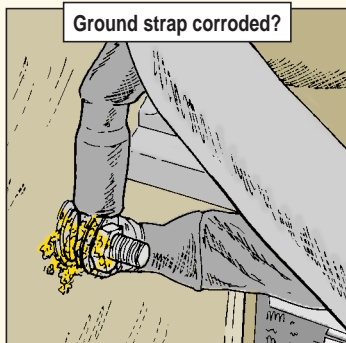
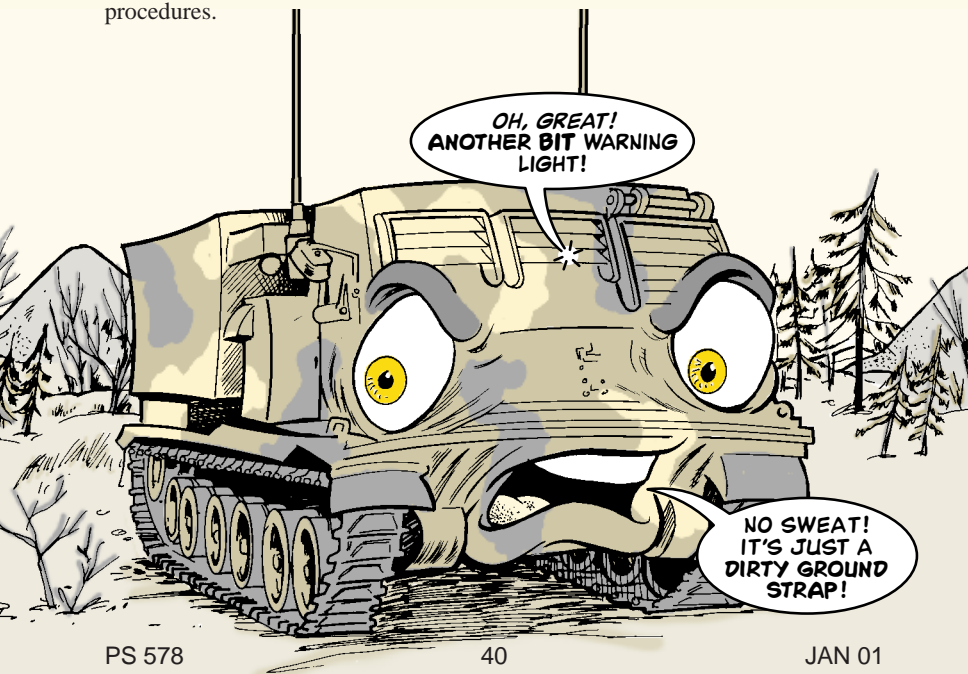
Before you go through any extensive troubleshooting, check the ground straps for all line replaceable units (LRUs). A loose mounting nut or corroded connector means the LRU loses its ground. On comes the BIT light associated with that LRU.

If you spot problems, call in your mechanic. He'll clean and tighten the strap and give it a light coat of varnish, NSN 8010-00-180-6343. That'll keep the corrosion from coming back.

After you reset the fire control panel the BIT light problem should be cleared up. If not, start your troubleshooting procedures.
